# EDIFICIO PIEDRA REAL – CONCEPCION, CHILE CASE STUDY OF AN UPLIFT REINFORCEMENT PROJECT

The following article presents the case study of the project "Piedra Real", located in Concepcion, the 2<sup>nd</sup> largest city of Chile. The border conditions of the project, as well as it's specific geological and geotechnical parameters will be briefly described.

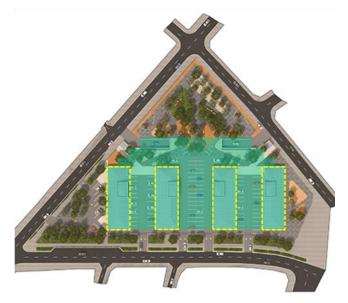
The condo consists in four 18-storey buildings, with two underground parking levels. The foundation of the complex was materialized by a reinforced concrete slab, with a surface of about 5680m<sup>2</sup>. The projection of the towers occupies about 40% of the total building area (Figure 2).

Figure 2 – Overview Condo Piedra Real (Concepcion, Chile)

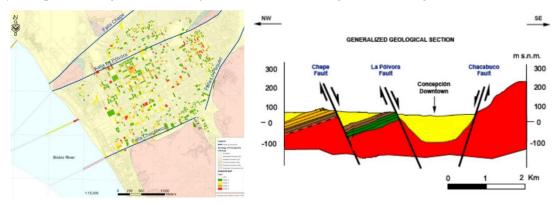
The city of Concepción is built on Tertiary sediments in a valley created by a graben, with metamorphic and granitic formations to the north, east, south, and beneath these Tertiary sediments. The sedimentary valley is depicted along with the 3 major faults that run through the area (Figure 3, [9]).

Figure 3 - Geology map and cross-section (NW-SE) of Concepcion [9]

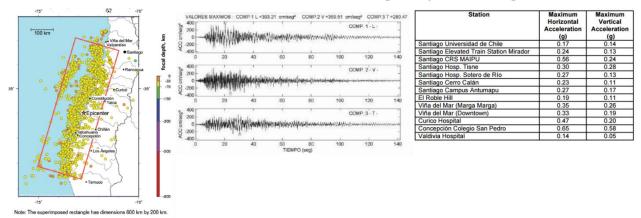
The earthquake-induced ground shaking had a total duration of about 140 s, with the strongest part lasting 40 -50 s [1]. In the region of strongest ground shaking, ground accelerations exceeded 0.05g for over 60 s in most of the records, and more than 120 s in the records corresponding to the Concepcion area [6].

Figure 4 – Left: Main shocks and aftershocks of Mw ≥ 4 between 2/27/10 and 3/26/10 [1], Middle: Strong motion record of Downtown Concepcion [13], Right: Preliminary Processed Records Maximum Accelerations [6]

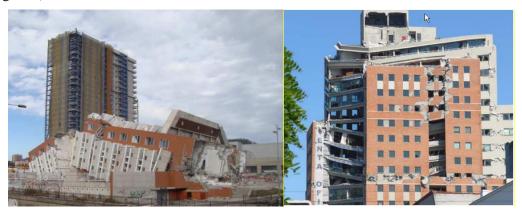
Examples of severe damage were observed in Concepcion, mostly in its downtown area, where one building fully collapsed (Alto Rio Tower) and several others had to be demolished due to partial failure at localized floors (Figure 5).

Figure 5 – Alto Rio Tower (fully collapsed, left) and O'Higgins Tower (partially collapsed, right) [2]

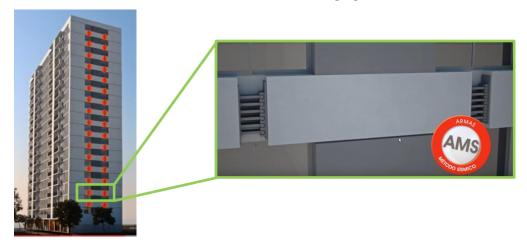
The towers were conceived with seismic dissipaters installed at the sides (Figure 6), in order to reduce the seismic effects both in the structural and non-structural elements [12].

Figure 6 – Seismic dissipaters installed at the sides of the towers [12]

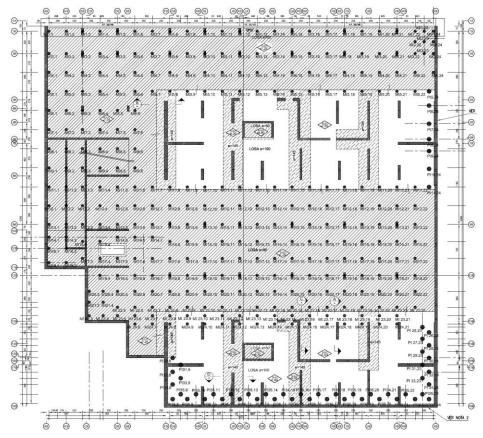
The distribution of the required reinforcement is presented in Figure 7 (for half of the structure), and summarized Table 2 (for tension loads)

Figure 7 – Distribution of the required foundation reinforcement [16]

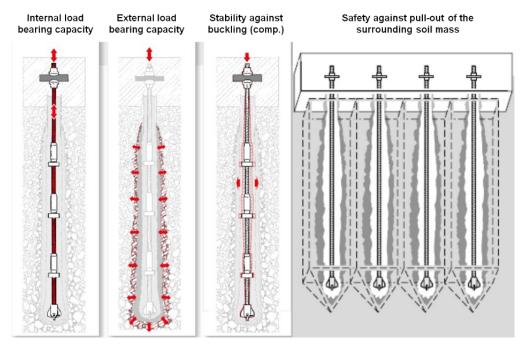
has to be verified for all limit states (ultimate and serviceability). Figure 8 displays the geotechnical verifications required for the design of the uplift reinforcement and the results are summarized in Table 3.

Figure 8 – Geotechnical verifications for the design of micropiles [7]

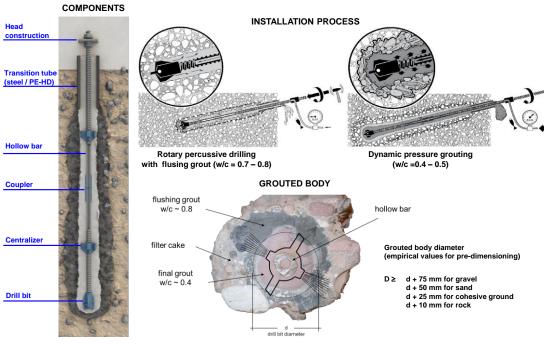
The TITAN micropiles consist of continuously threaded hollow bars, made out of seamless fine-grained steel pipes (S460 NH), installed via rotary percussive drilling. During the drilling process, the micropiles are continuously grouted (dynamic injection), building a rough interlocking at the interface grout-soil, increasing the skin friction. According to [10], the characteristic skin friction value of  $\mathbf{q}_{s,k} = 215 kN/m^2$  was adopted for the layer H3.

The components, the installation process and a typical cross-section of the grouted body are presented in Figure 9.

Figure 9 – TITAN System: components, installation process and grouted body [7]

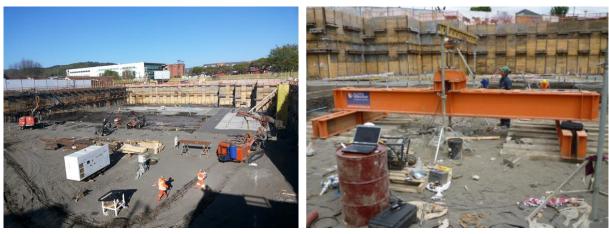
The micropiles were installed from the bottom of the excavation pit (Figure 11). Up to three drilling machines were used for the installation: two Tamrock rigs and one Morath drifter (HB70), attached to a telescopic jib (Manitou). The achieved drilling performance was approx. 100m/day/equipment.

Figure 11 – Installation of the micropiles (left) and load tests (right)

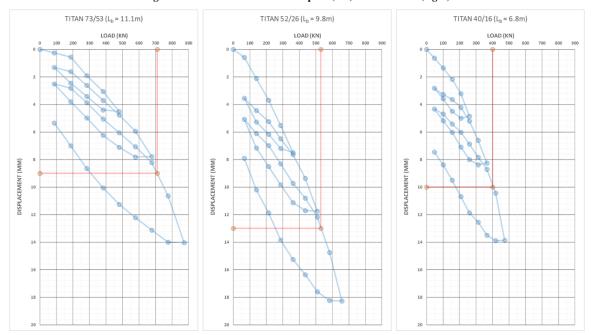
After installation, load tests were carried out in order to verify the adopted design considerations, especially regarding the skin friction of the layer H3. Three test micropiles were executed: 1x73/53, 1x52/26 and 1x40/16. The micropiles were subjected to maximum test loads, equal to 90% of the yield force (at 0.2% elongation) for the correspondent micropile type, without reaching the ultimate limit state of the pull-out resistance (Figure 12). The required safety level and the adopted design considerations were validated. The registered displacements for the design loads were between 9 and 13mm.

Figure 12 - Results of the executed load tests

According to [11] the required grout cover for the micropiles considered in the design was 40mm, in order to guarantee the permanent corrosion protection. The measurements at the micropiles necks showed grout covers of at least 45mm, fulfilling the requirements for the durability.

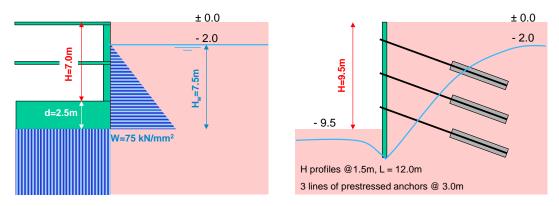
During the preliminary engineering approach, a 2.5m-thick bottom slab was consider to resist the uplift forces thus for the planned two underground parking levels, the project required an excavation pit with a free height of 9.5m. For this matter, a temporary excavation shoring consisting of an anchored soldier pile wall and a network of well-points to lower the groundwater had to be implemented. The corresponding requirement is schematically presented in Figure 13.

Figure 13 - Preliminary design approach (left) and constructive measures for the temporary excavation shoring (right)

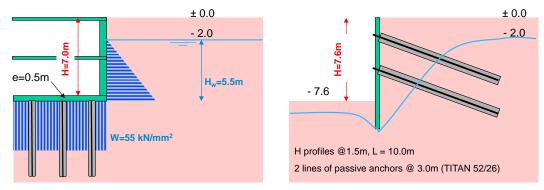
The implementation of the presented uplift reinforcement solution had also a positive effect in the temporary shoring and groundwater lowering, since the excavation depth was considerably reduced to 7.6m, making possible to optimize the design of the above mentioned items (Figure 14).

Figure 14 - Adopted design approach (left) and constructive measures for the temporary excavation shoring (right)

The lateral support for the soldier pile wall was also materialized with TITAN tension piles (passive anchors). This solution was also proven to be more convenient than the originally considered use of strand anchors, since the higher installation speed of self-drilling anchors (>100meter/day) enabled to finish the excavation shoring faster. Furthermore, the installation of anchors and micropiles was carried out using the same equipment, simplifying the logistic at the construction site and reducing its costs (i.e. mobilization).
