**PROCEEDINGS OF
TWO SEMINARS OF TC207 ISSMGE
in 2015**

**SOIL-STRUCTURE INTERACTION
AND RETAINING WALLS**

Monitored deep excavation in the Ripio de Santiago de Chile

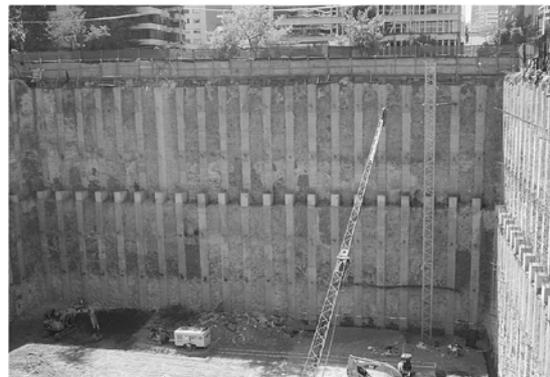
Figure 1. Deep excavation of 33 meters

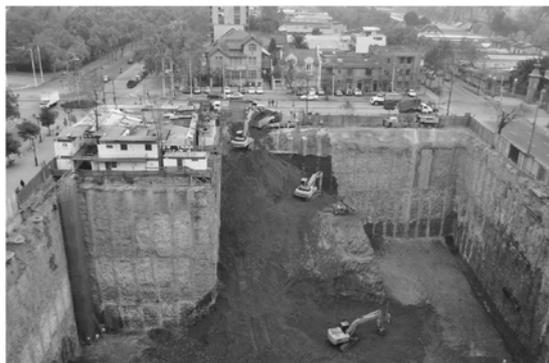
Figure 2. Deep excavation of 26,5m.

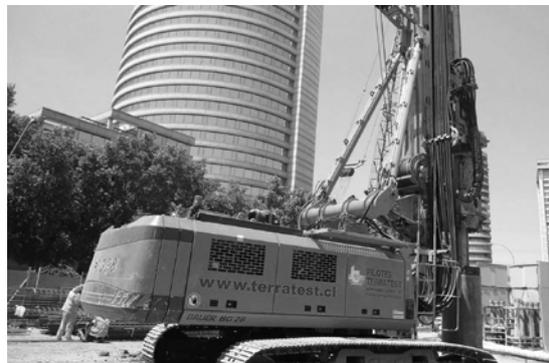
Figure 3. Bored cased piles being executed

Pilotes Terratest decided to monitor one of its projects in which its own Engineering design was to be executed in the Parque Oriente Building. Bored cased piles were executed in order to guarantee a minimum deviation of the wall due to the big boulders usually present.

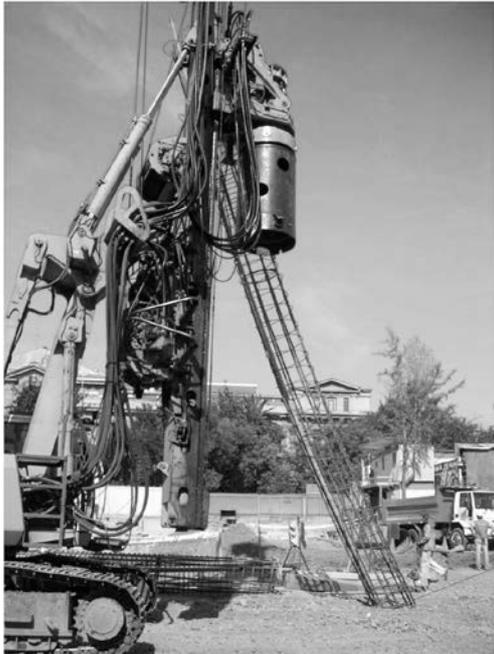
Figure 4. Installation of the pile reinforcement cage with the inclinometer tube attached

The typical section was 21,2m depth, and the monitored one was on the vicinity of the avenue Alonso de Cordova. An inclinometer casing was disposed in one pile attached to the reinforcement cage in its full length, and the two rows of ground anchors were instrumented with load cells when the sequence of construction applied. The inclinometer restriction in depth probed, after numerical analysis, not to influence more than 1mm the final stage readings because of the soil great rigidity.

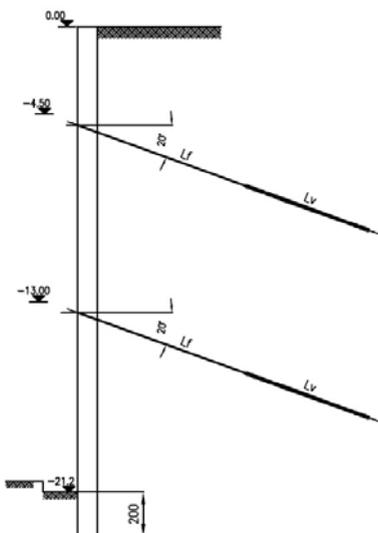
Figure 5. Cross section of the anchored pile wall.

Piles of 880 mm diameter were arranged every 3,20 m. In the monitored section, the first row of ground anchors was placed at 4,50 m depth and the second one at 13,0 m depth. The service loads of each anchor were 880 kN (275 kN/m) and 1245 kN (389kN/m) for the first and second row respectively.

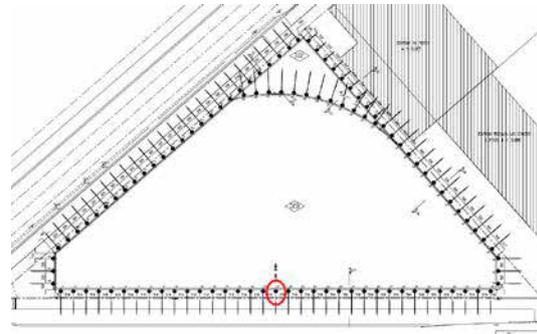
Figure 6. Excavation layout and monitored pile.

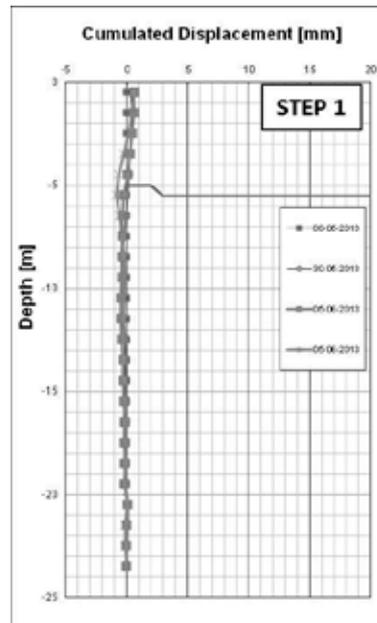
Figure 7. Horizontal deformations of stage 1.

The horizontal deformation of the pile in a cantilever behavior was of 1,3mm, and also was measured just before and after the anchor was tensioned and the wall moved 0,75mm backwards, and in the second row it was 0,45mm.

The first excavation stage was carried to 5,50 m depth where the first row anchors were executed.

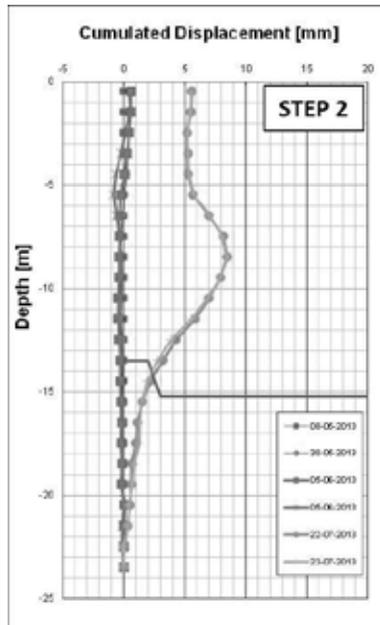
Figure 8. Horizontal deformations of stage 2.

The second excavation stage was carried to 13,50 m depth where the second row anchors were executed. The excavation continued to 15,50 m depth before tensioning the anchor. A berm was left in front of the piles to allow the tensioning works.

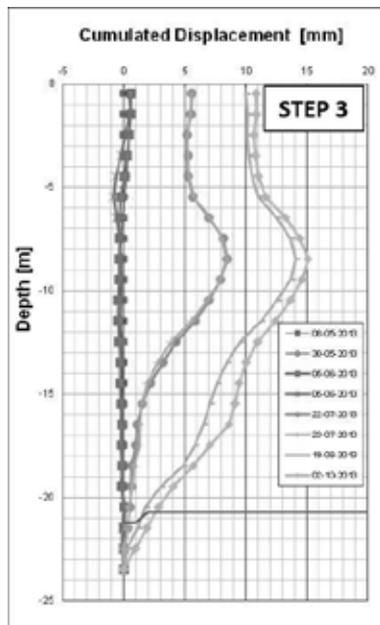
Figure 9. Horizontal deformations of stage 3.

The third excavation stage was carried to the maximum excavation depth. A maximum horizontal deformation of 15mm was measured at maximum excavation depth.

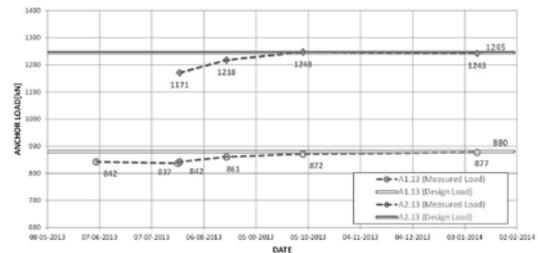
Figure 10. Ground anchor loads measured.

The anchors loads were also measured at the mentioned stages. The anchor load variation behaviour was coherent with the expected very low creep value (k_s) of the set soil-grout-steel and the measured deformation of the pile wall, related to its free length (specific deformation)

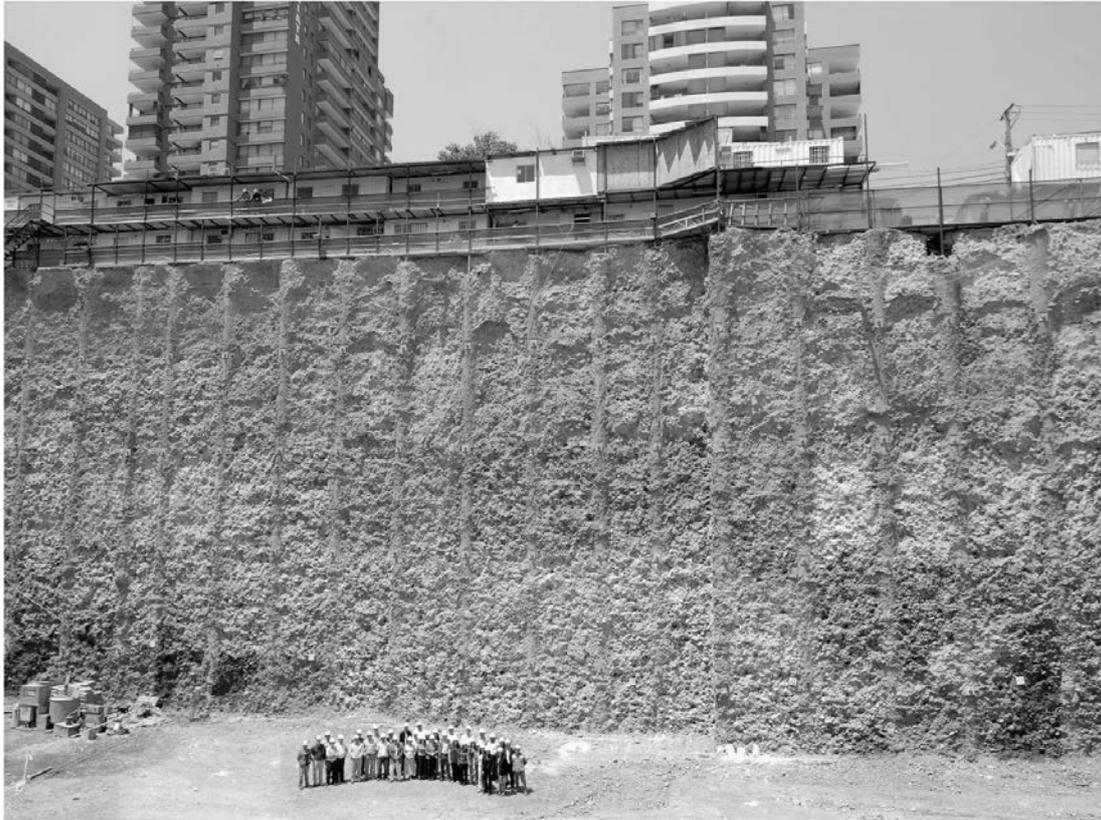
Figure 11. Deep excavation of 28 meters.

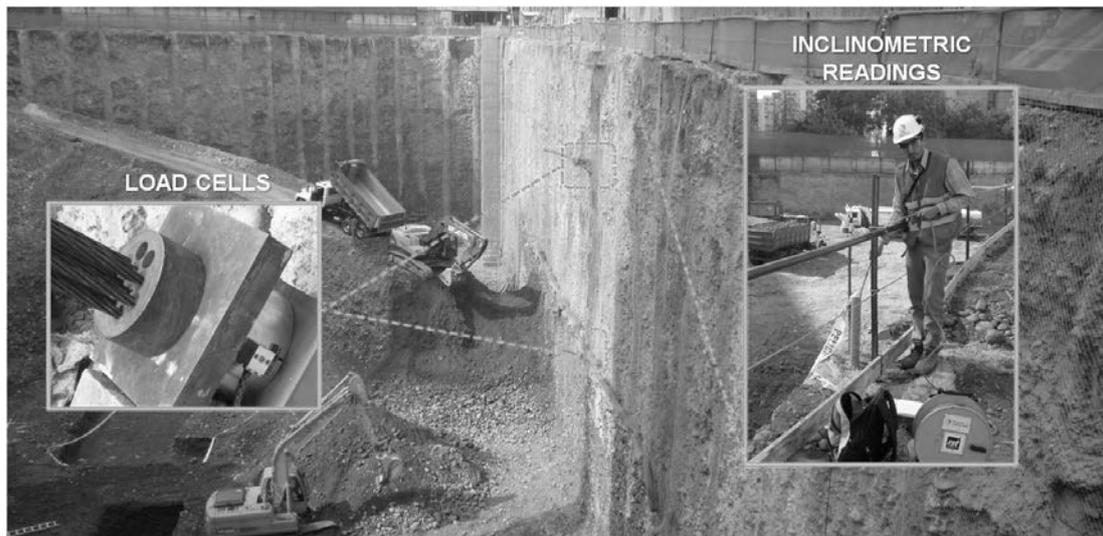
Figure 12. Inclinator and load cell readings.

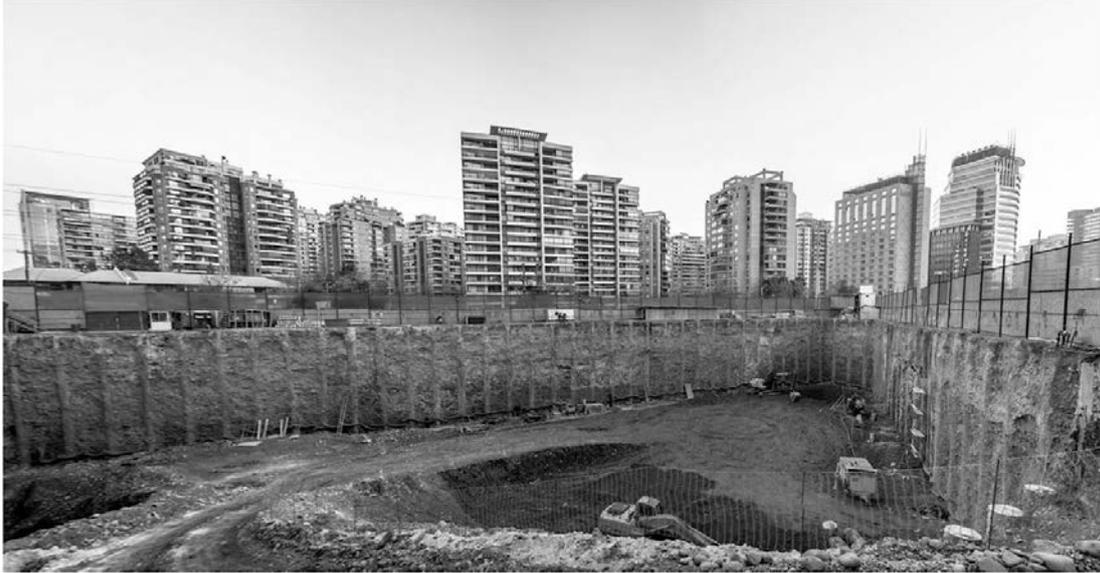
Figure 13.Parque Oriente building excavation completed.
